MISCELLANEOUS PAPER NO. 4-850

# EVALUATION OF GUIDE RAIL IN CONJUNCTION WITH KAISER AND HARVEY LANDING MAT (AM2)

October 1966

U. S. Army Engineer Waterways Experiment Station  
CORPS OF ENGINEERS  
Vicksburg, Mississippi

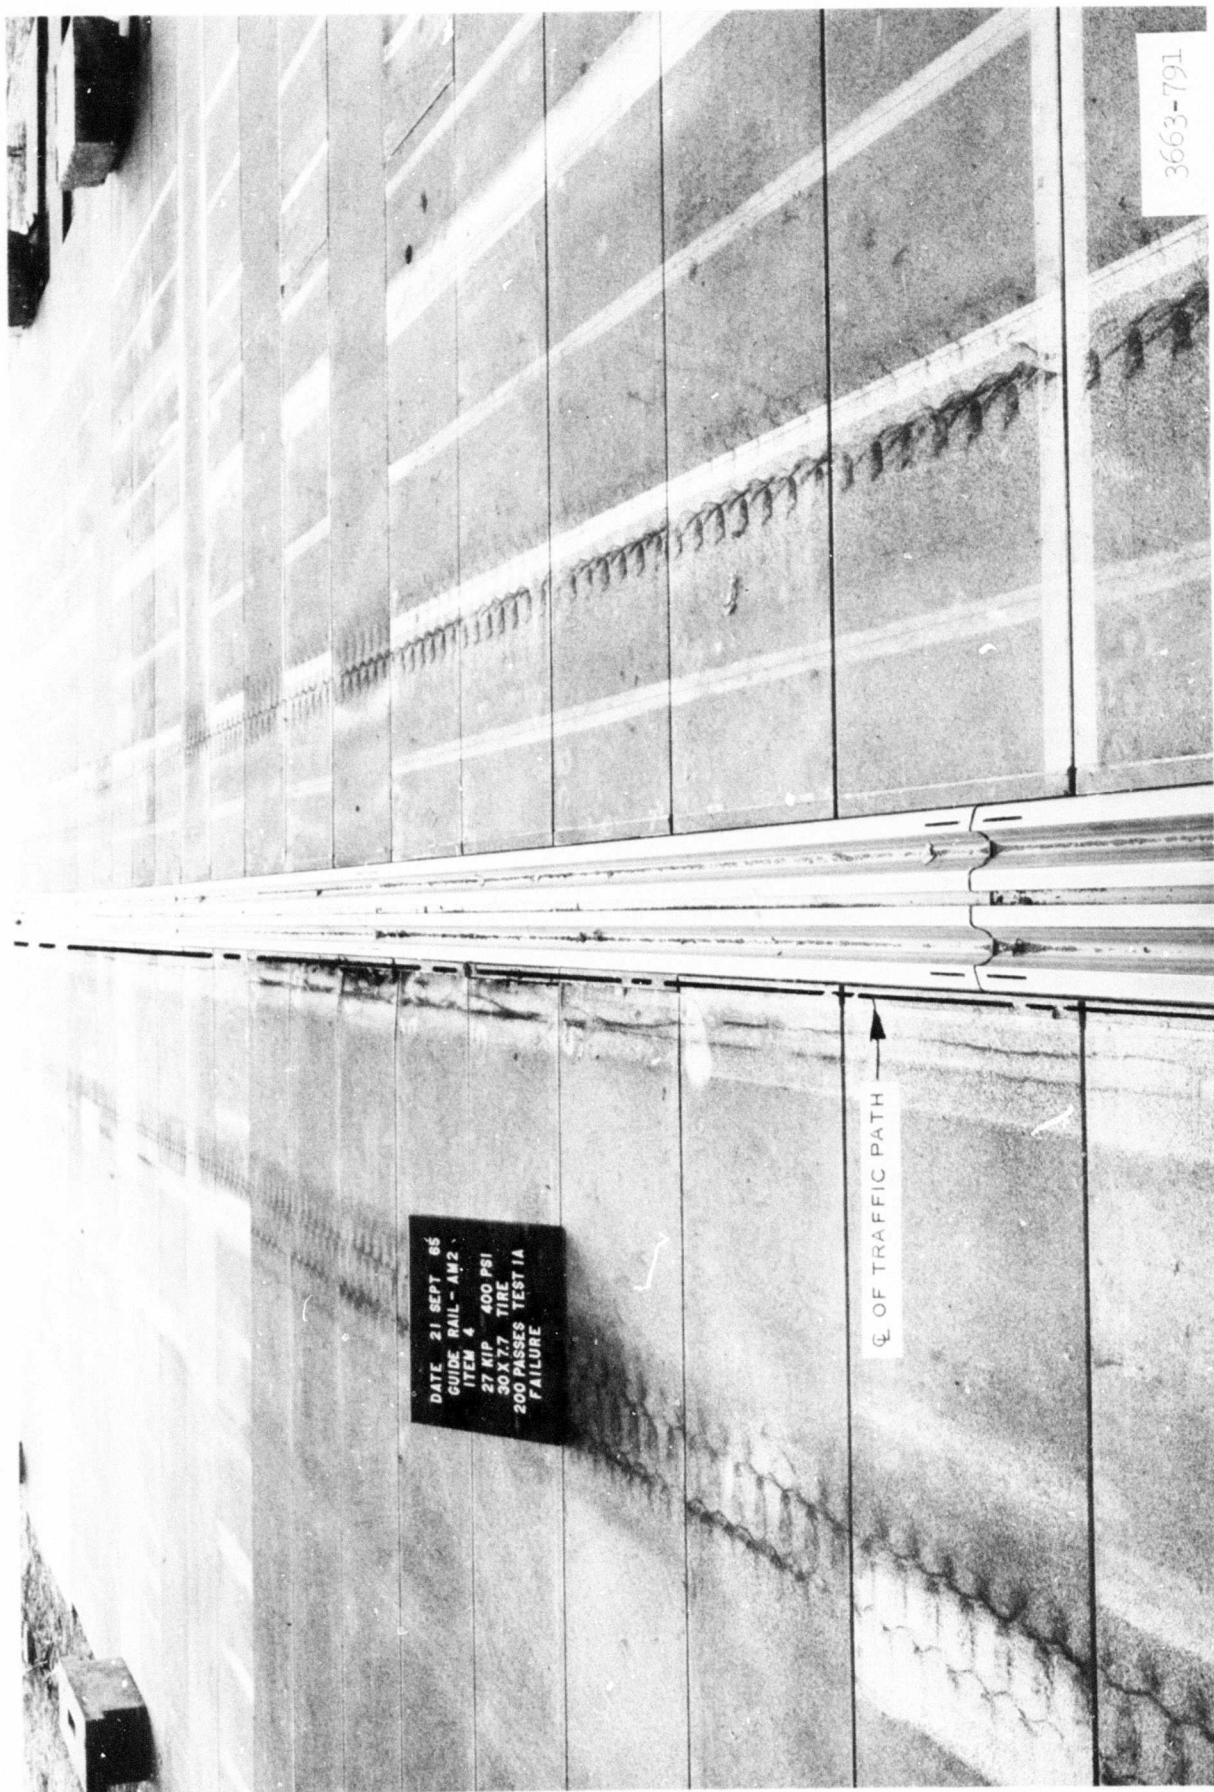
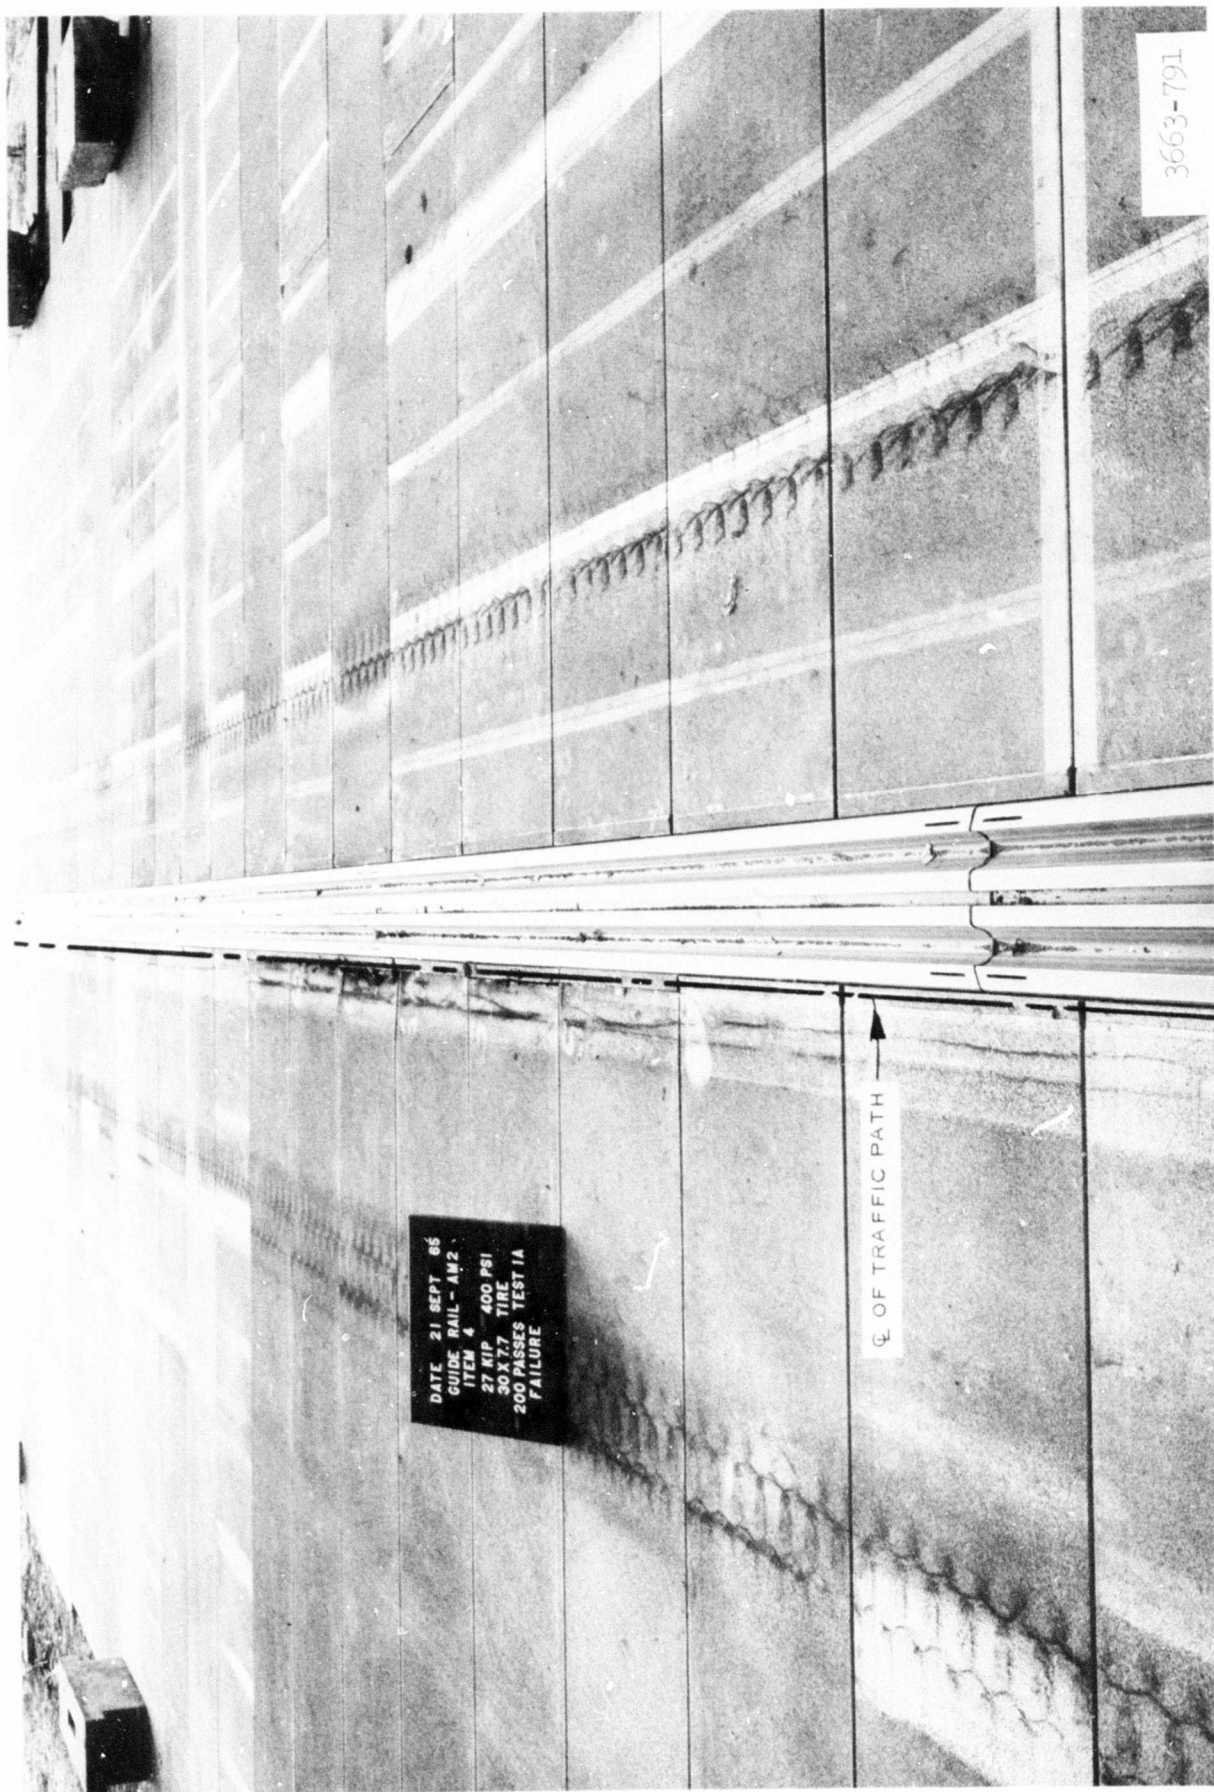
38. Visual observations. During the first few passes of the load wheel, cracks developed in end-joint welds in three of the six old AM2 planks without the modified end joints, and after 17 passes, these joints had completely separated. After 40 passes, all six of the old planks had failed. All other mat in the test lane was in good condition. After 200 passes, four of the Harvey modified AM2 planks in item 4 had failed because of weld failures at end joints. A general view of the failed end joints is shown in photograph 16. All other mat in the test lane was in satisfactory condition. The two Kaiser 4- by 4-ft planks of honeycomb mat in item 4 were still in good condition at the end of 200 passes; however, these planks were located at the extreme north end of item 4 and could not be subjected to further traffic without continuing traffic over the failed

Photograph 16. End-joint failures in test item 4

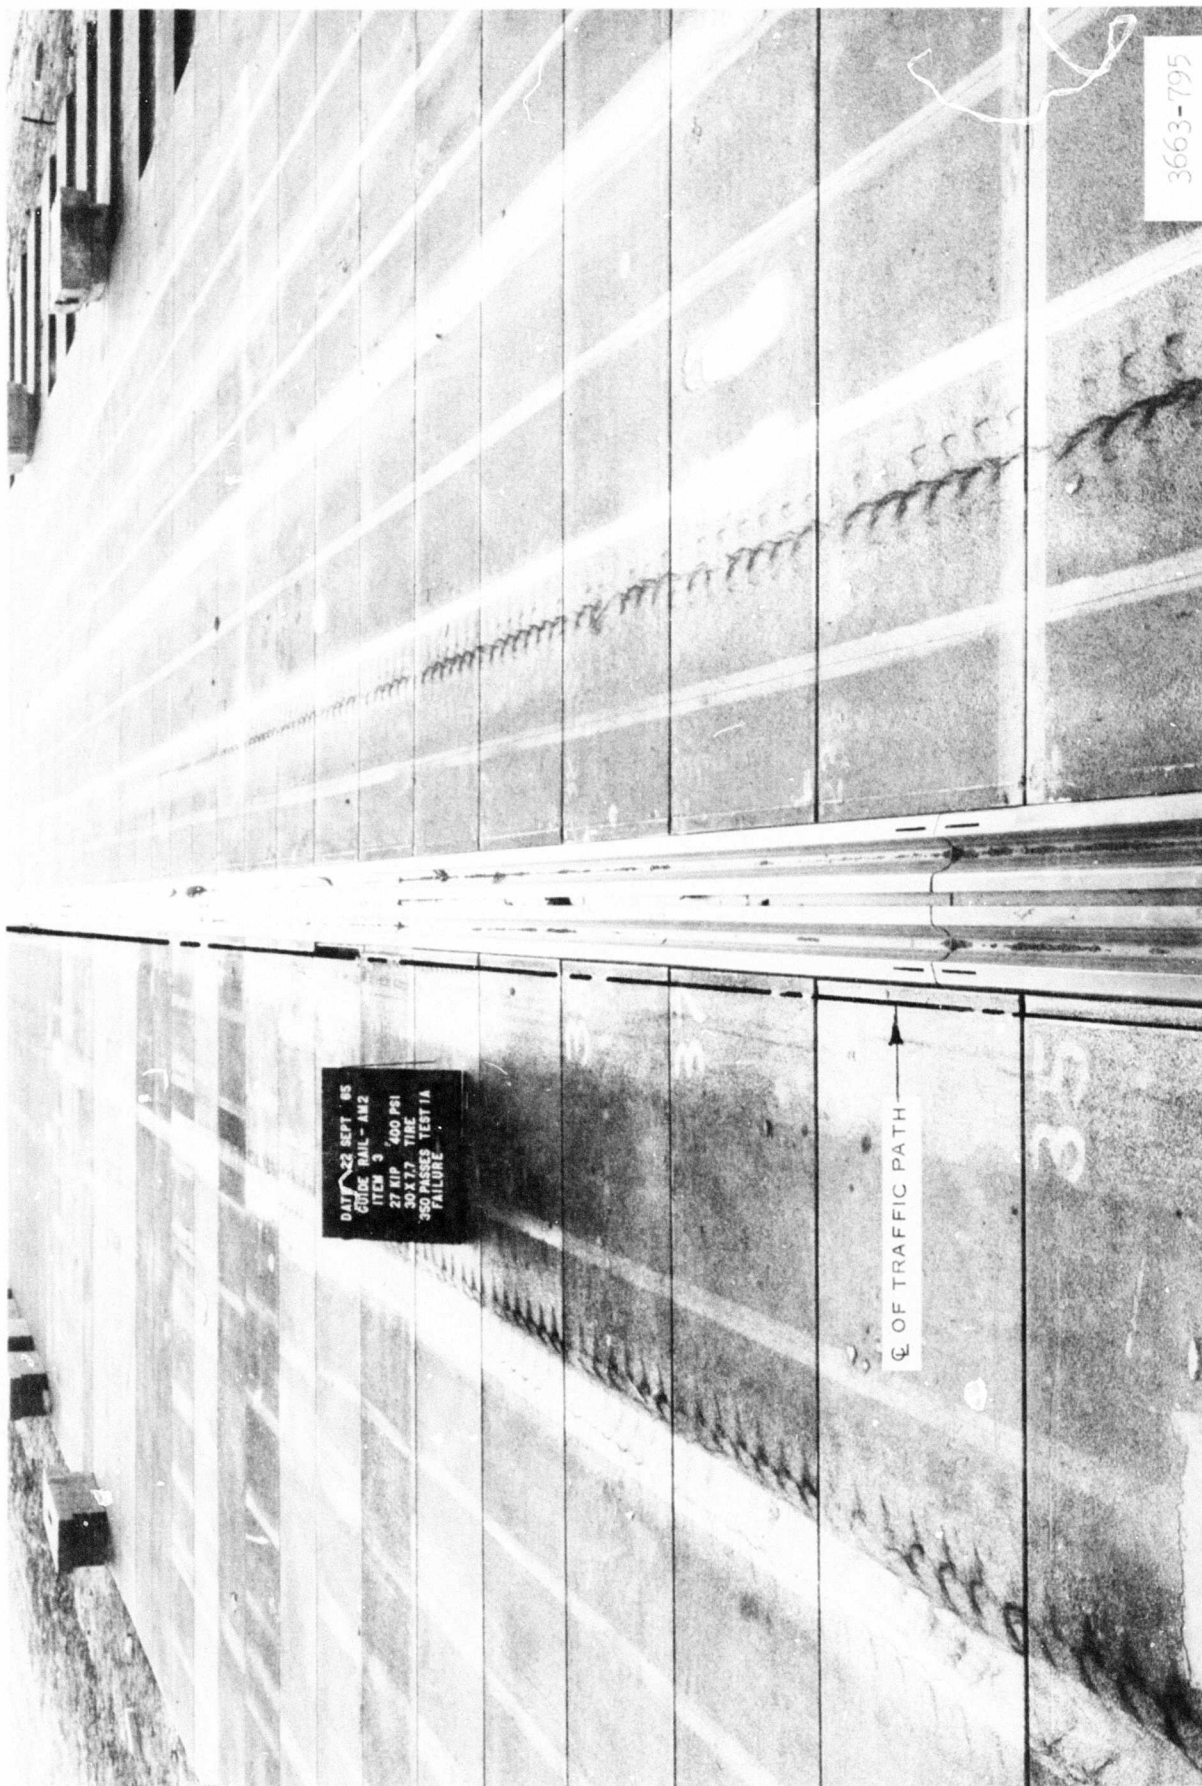
40. As traffic was continued, weld cracks began to develop in some planks of all test items. After 350 passes, the end joints had failed in eight planks in item 3 (photograph 18). At this point traffic was discontinued on this item. At this stage of traffic, only one joint failure had developed in item 1 and no failures had developed in item 2. After 800 passes, five end joints had failed in both items 1 and 2 with failure imminent in a number of other planks. Traffic was discontinued at this point. A view of items 1 and 2 at the end of traffic is shown in photographs 19 and 20, respectively. The traffic applied in the test lane resulted in no visual damage to the guide rail.

Photograph 18. Test item 3, lane 1-a, after 350 passes of load wheel

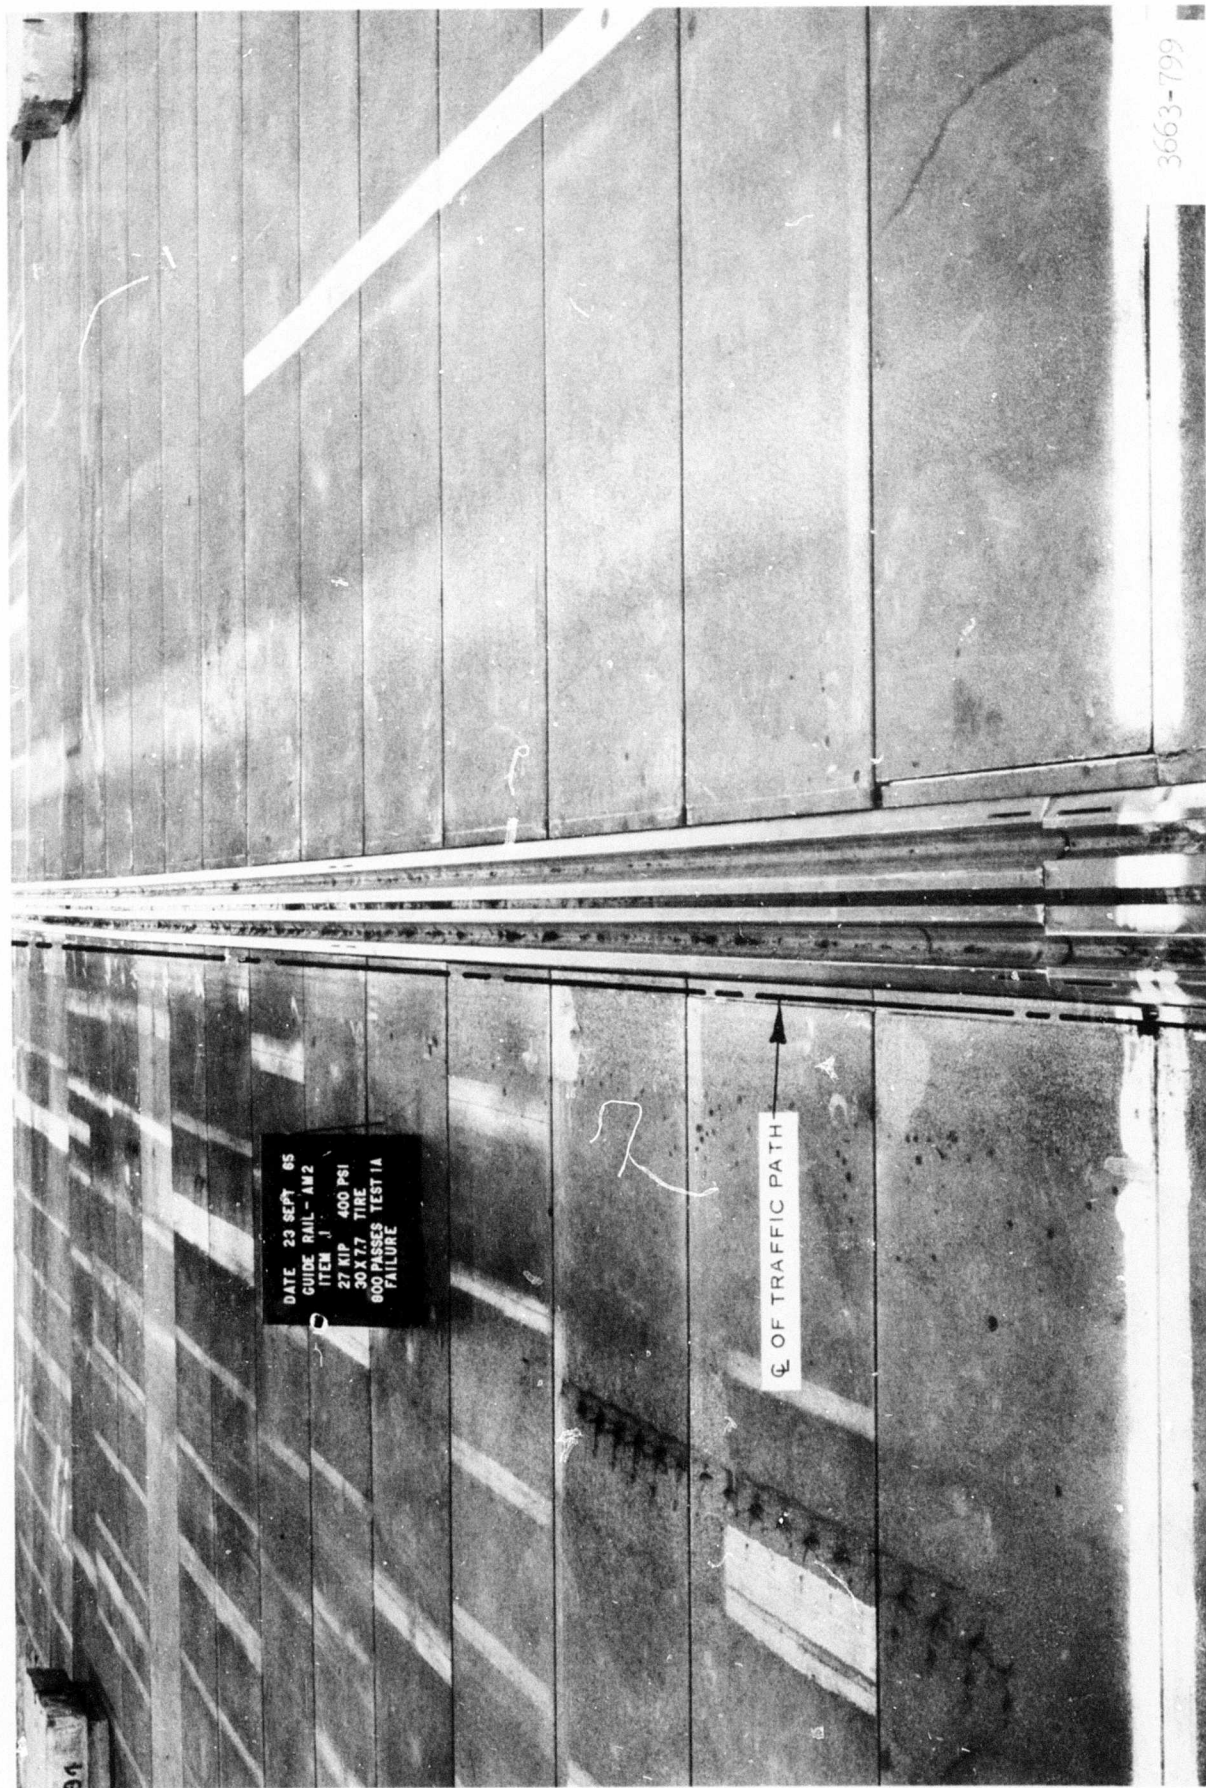
Photograph 19. Test item 1, lane 1-a, after 800 passes of load wheel

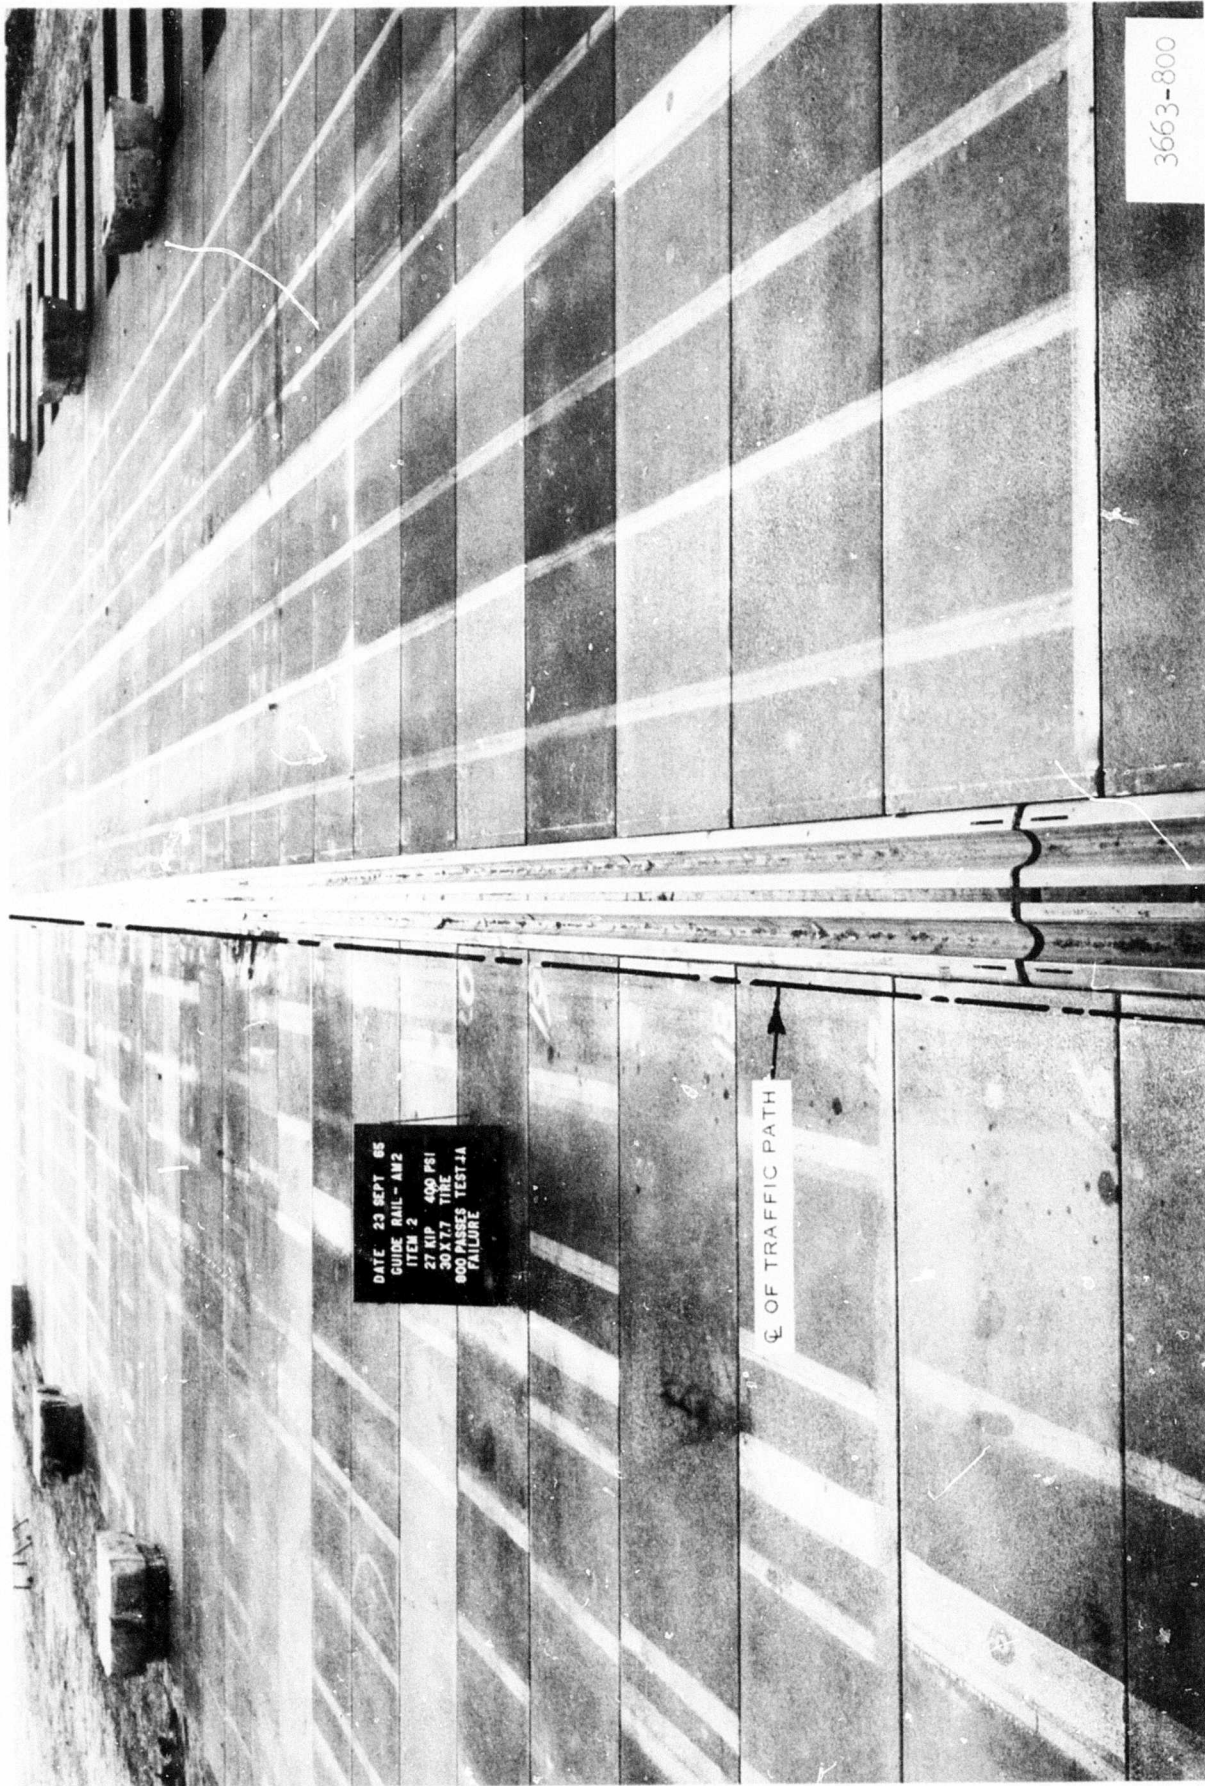
Photograph 20. Test item 2, lane 1-a, after 800 passes of load wheel

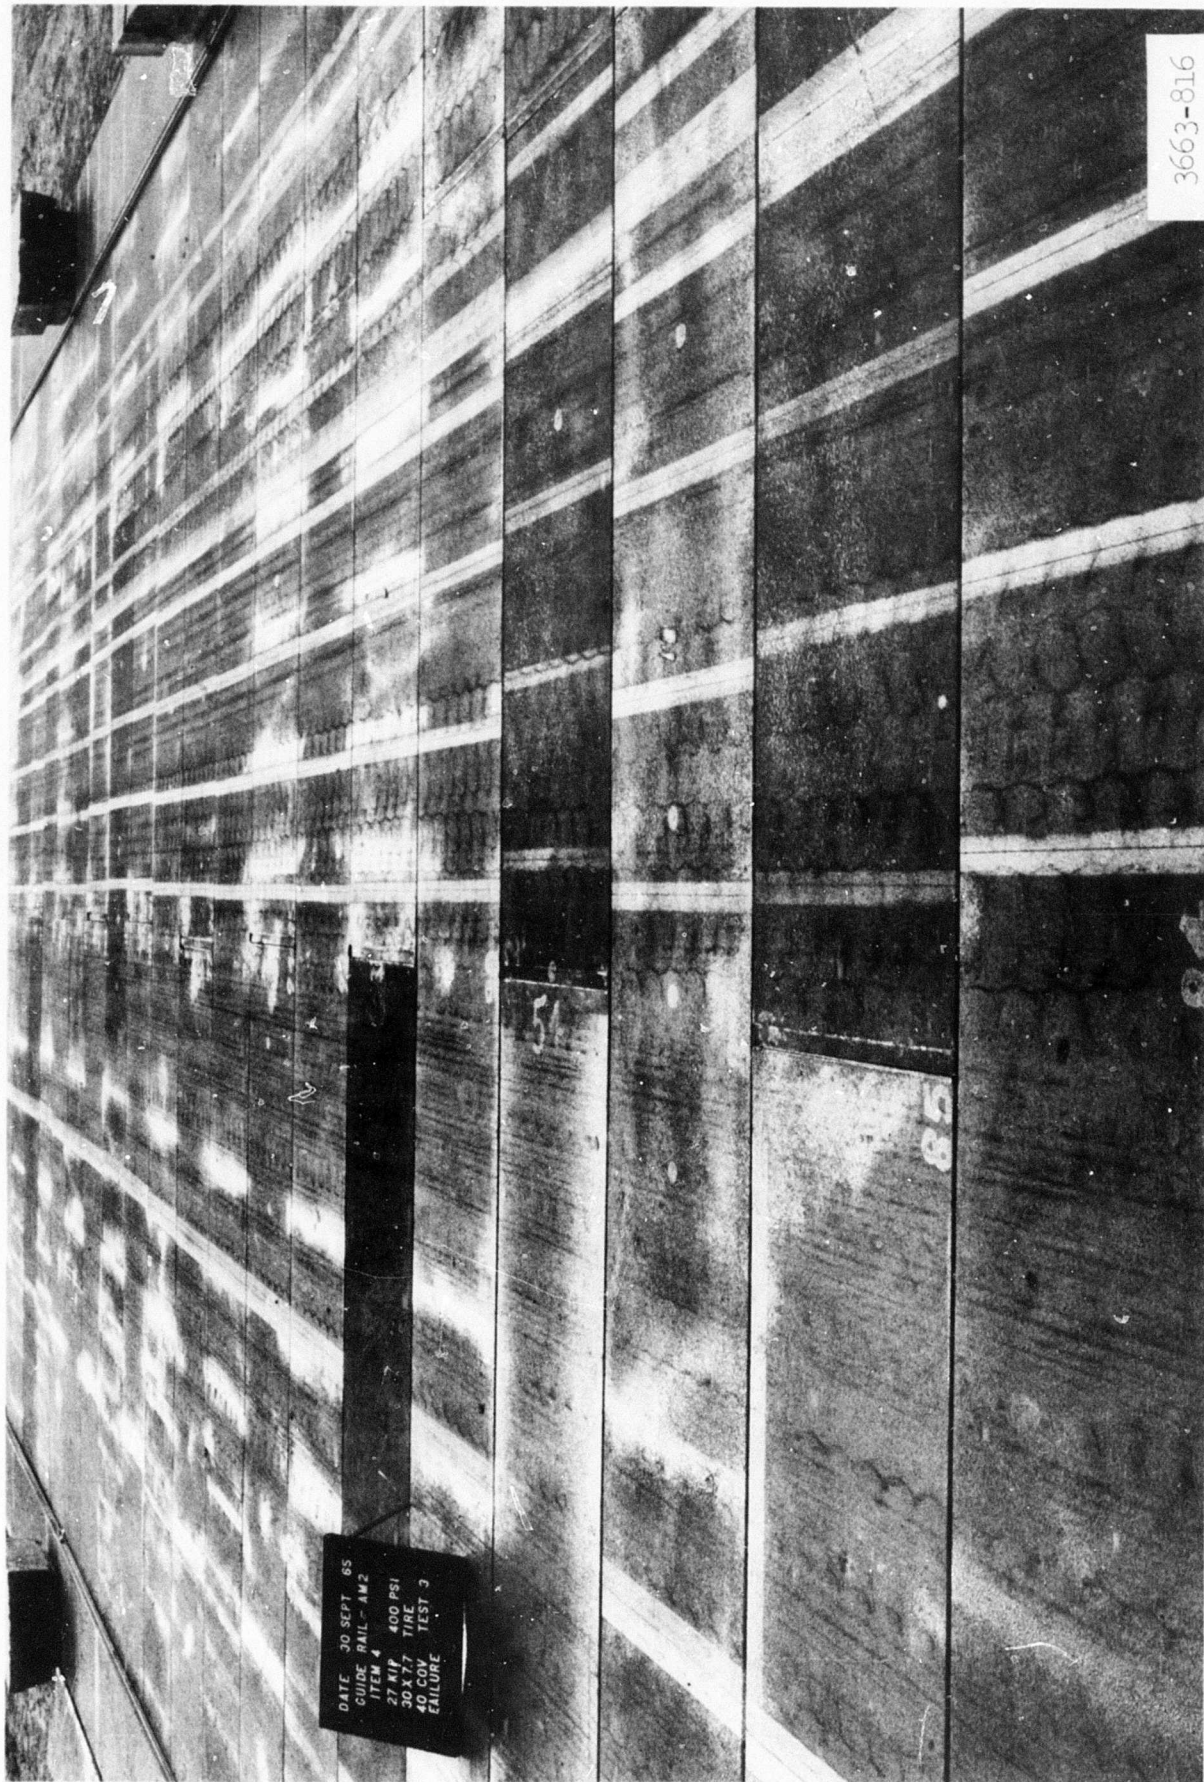
Photograph 22. Item 4, lane 3, after 40 coverages of load wheel

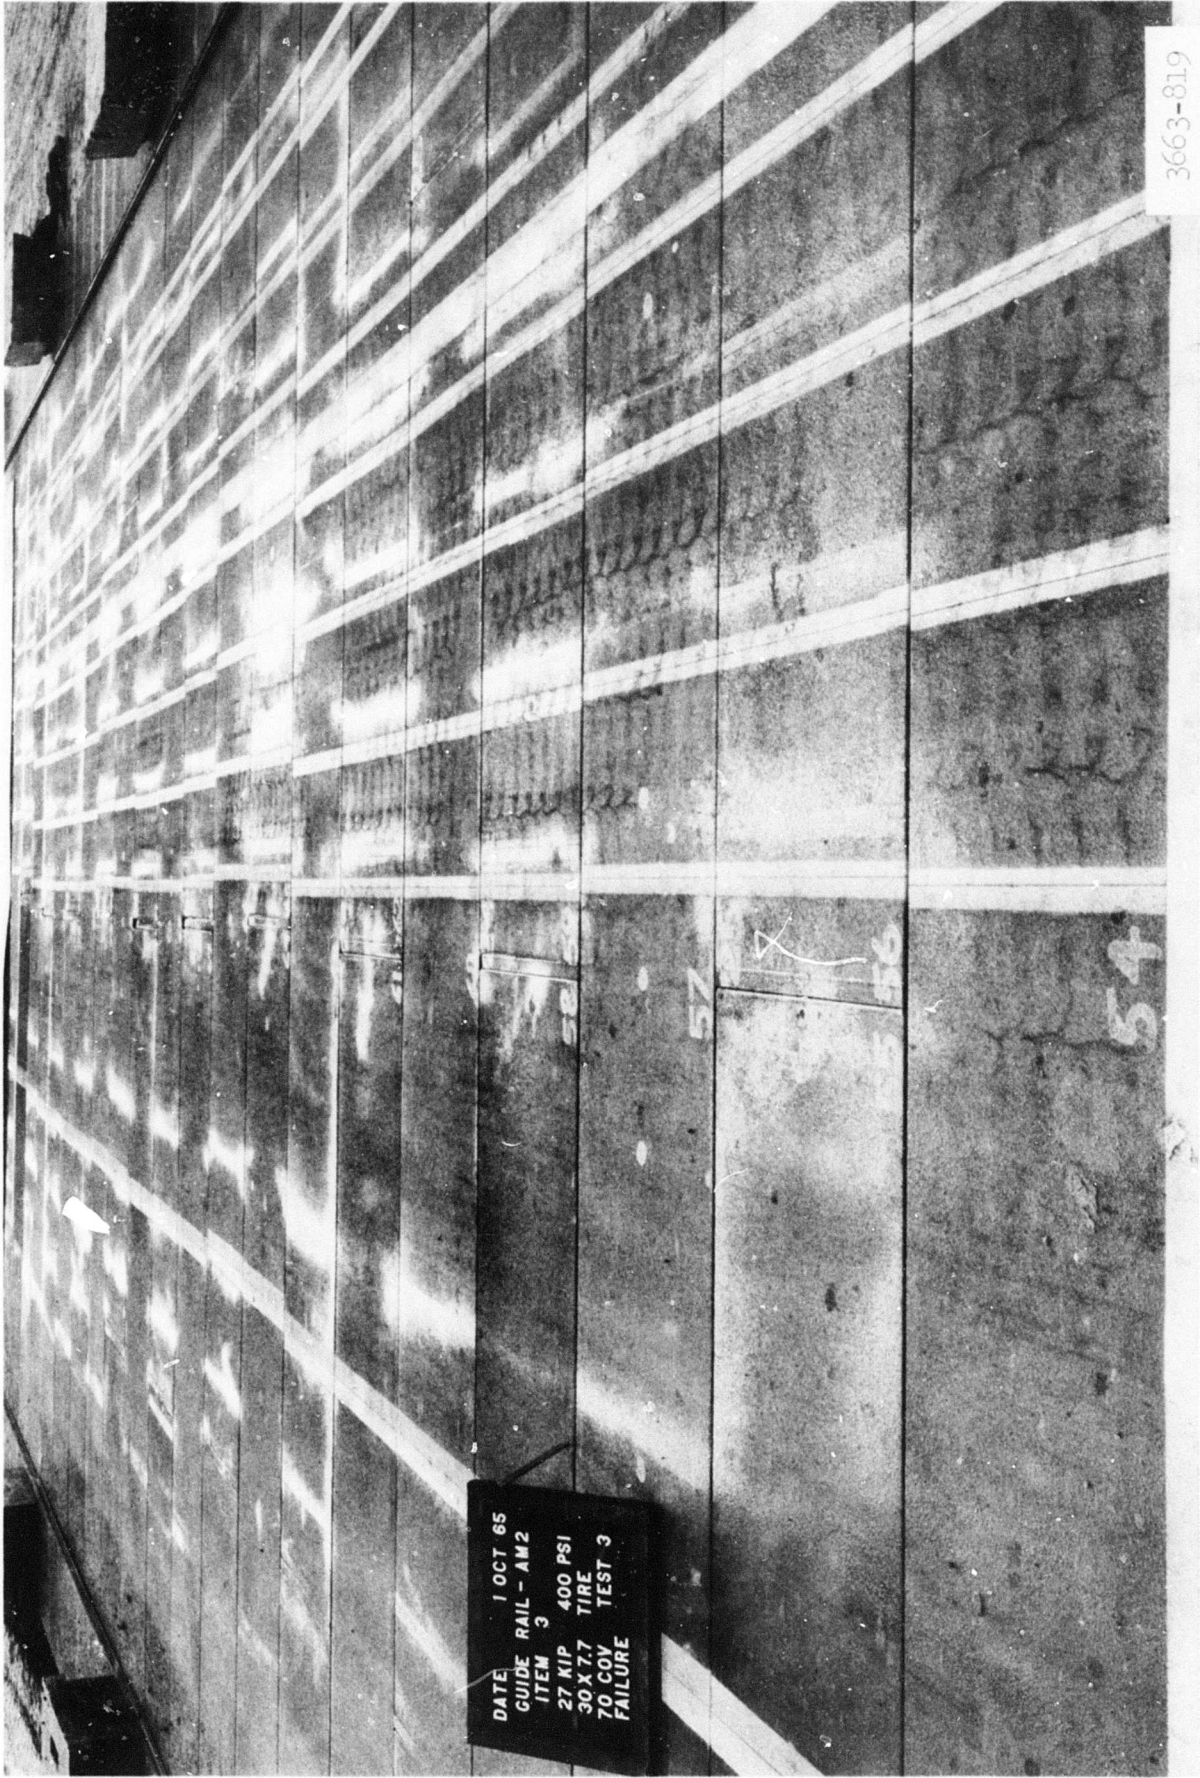
43. As traffic was continued on items 1, 2, and 3, similar end-joint weld failures developed in items 2 and 3, but at a more rapid rate in item 3. After 70 coverages, the end-joint welds on seven planks in item 3 had completely failed, and traffic on this item was discontinued. A general view of item 3 at the end of traffic is shown in photograph 23. Traffic was continued on items 1 and 2 to a total of 188 coverages, at which point nine end-joint weld failures had developed in item 2, but no failures or weld cracks had developed in any of the mat planks in item 1.

Photograph 23. Item 3, lane 3, after 70 coverages of load wheel
